**FIELD ACTIVITIES REPORT
Mine Adit Entry**

**RED AND BONITA MINE SITE
Silverton, San Juan County, Colorado**

TDD No. 1008-01

January 20, 2012

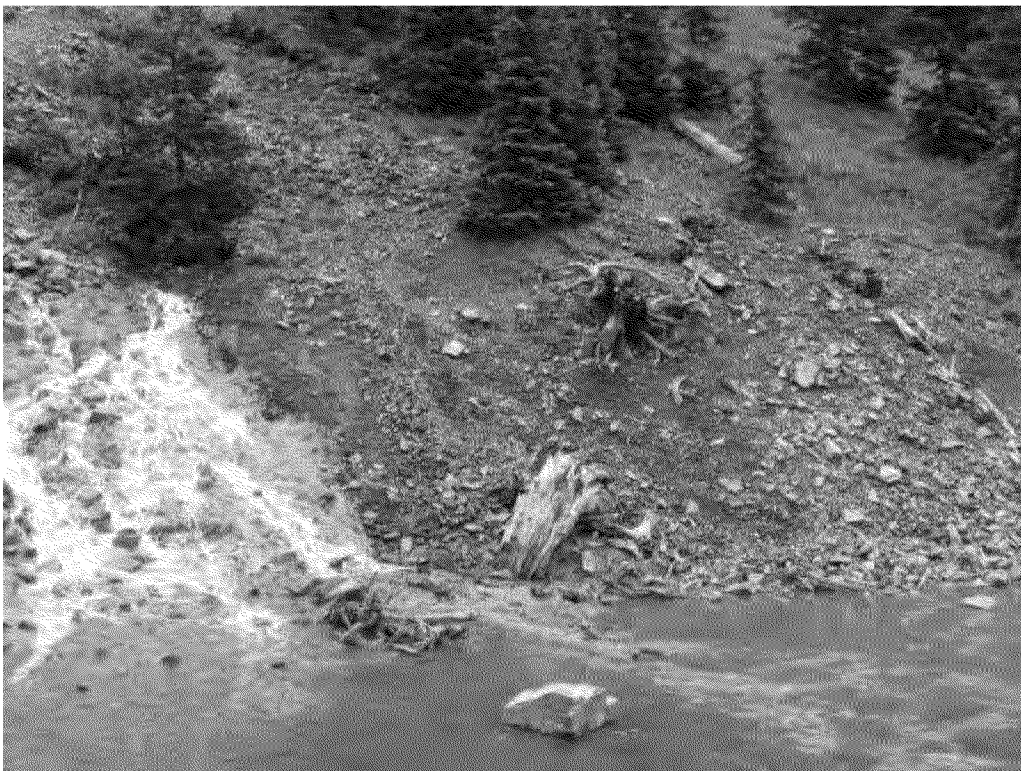
PHOTO 12 8-24-2011

Field conditions prior to adit entry activities. AMD flowing from mountain side at apparent adit location.

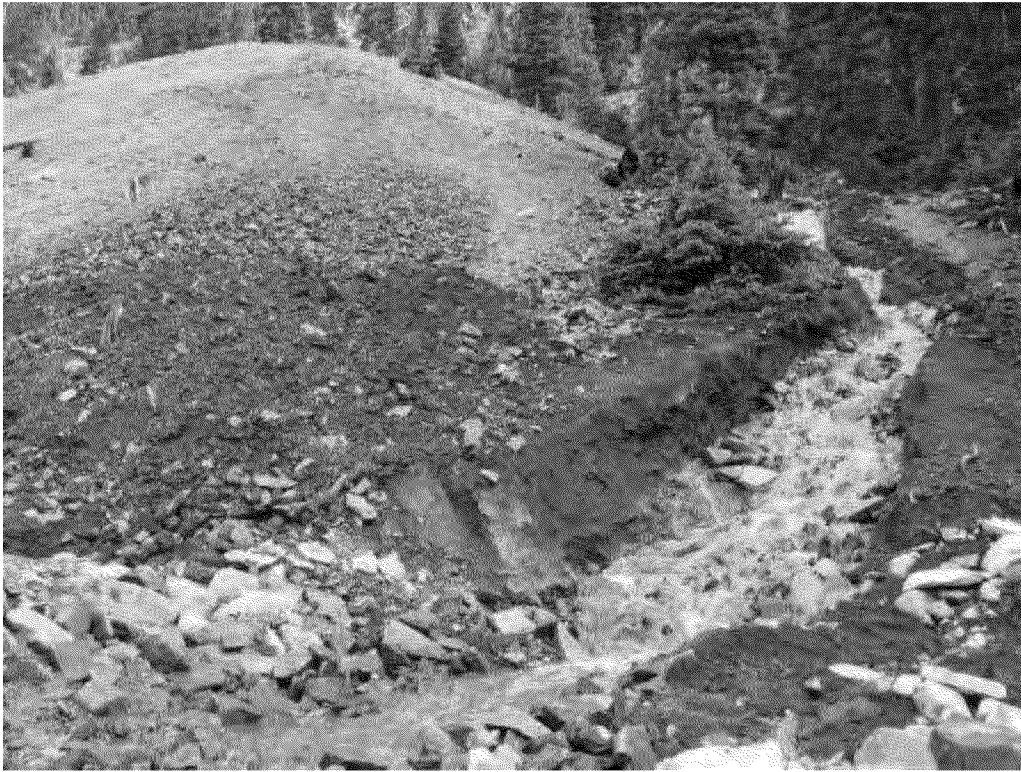
PHOTO 13 8-29-2011

Initial diversion flow from adit into south ditch. Red color derived from ditch sediments washing out.

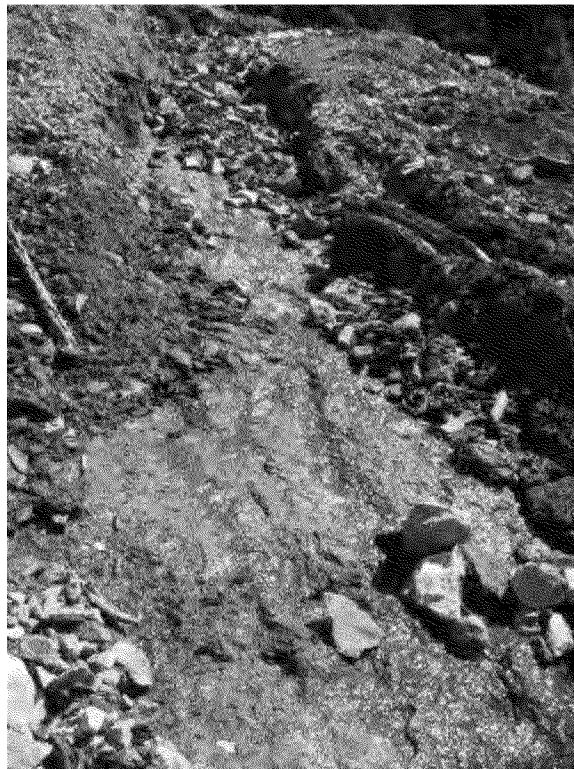
PHOTO 14 8-30-2011

Evidence of the existence of ferricrete south of the mine site lies in the fact that when water flowed within the south ditch (i.e., on top of the ferricrete), three seeps were observed to form within hours of water placement into the ditch at locations downgradient (south) of the ditch, likely indicating flow along the impervious ferricrete plane. Seep flow ceased when water was diverted from the ditch. Two seeps were newly created while one existing seep appeared to have an enhanced flow. The seeps were located approximately 50 feet, 115 feet, and 170 feet south of the south ditch, each in subsequently hydraulically lower locations, and flowed at visual estimates of 0.5 gpm, 2 gpm, and 5 gpm, respectively, for short distances before re-entering the ground. Water flow observed below the seeps from the upgradient bank of the south access road-cut flowed at a visually estimated rate of 1 gpm prior to diverting flow into the south ditch, but increased to approximately 25 gpm during periods of water flow within the south ditch.

South ditch flow temporarily diverted. Red-colored resistant ferricrete underlying thin soil and dump material.

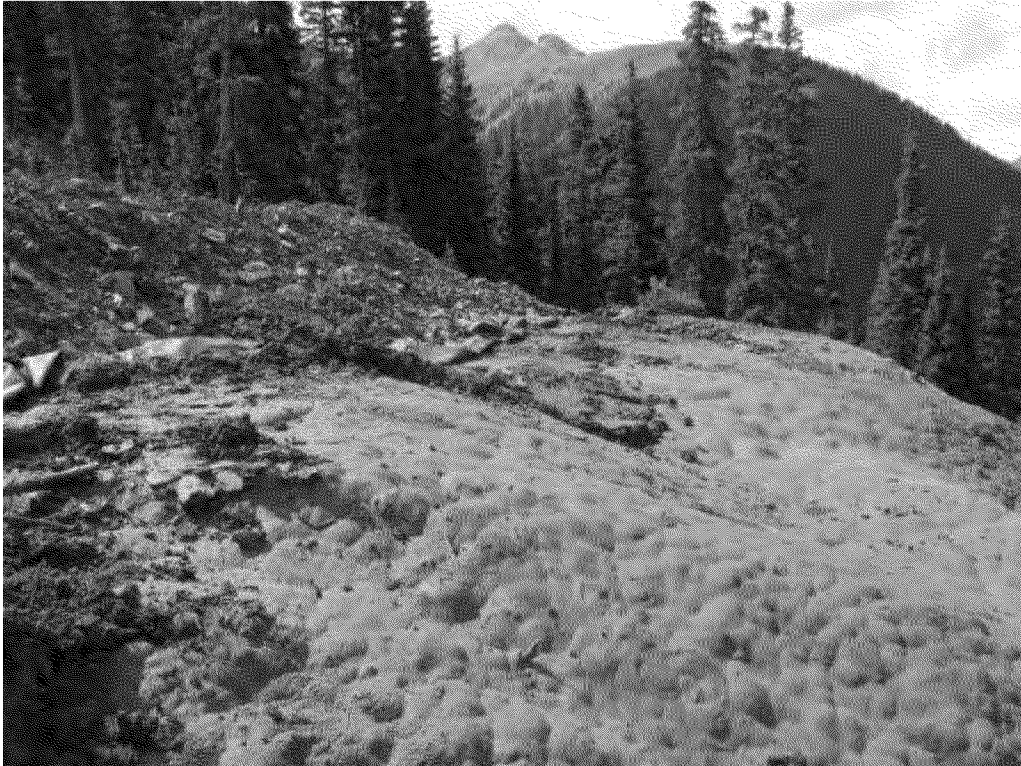
PHOTO 20 9-8-2011

Toe of prepared dump surface at head of dump face. Note geotextile fabric liner exposed under talus, and armored yellow boy surface on dump face.

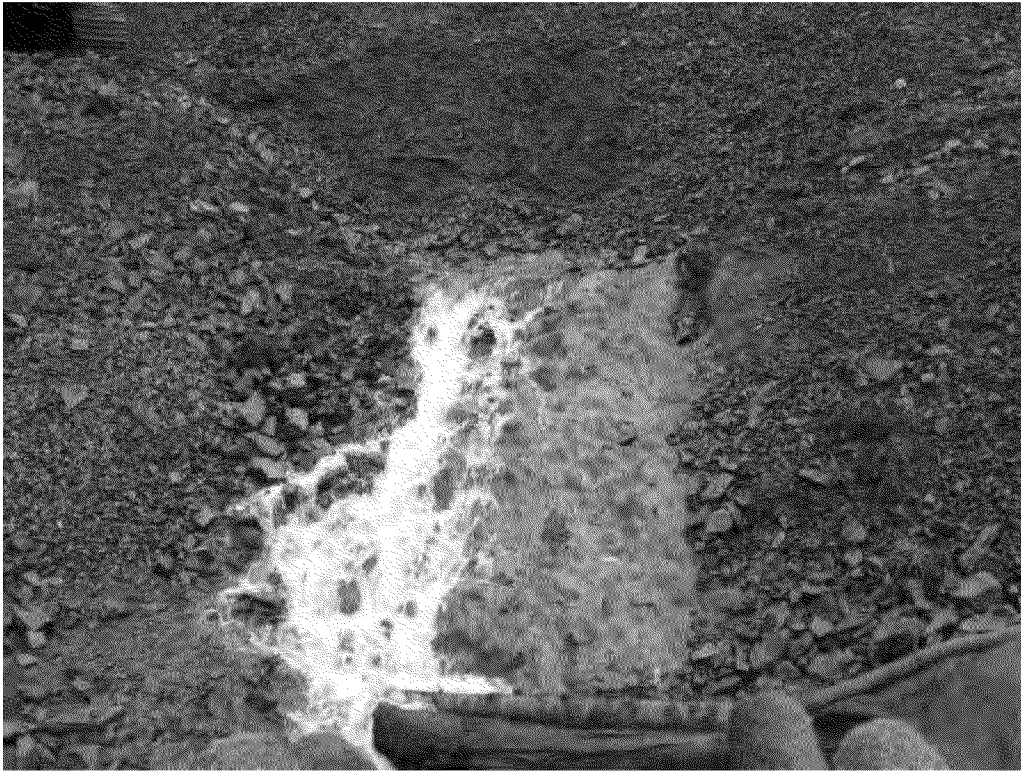
PHOTO 25 9-11-2011

During excavation activities, AMD effluent water was observed to flow through the collapsed material from a distinct upper horizontal limit, as determined by yellow boy staining. This upper limit line coincided with the current adit flow, and was later discovered to coincide with some of the rail spiling. Upon additional excavation it was determined that AMD effluent water was releasing from the adit at the roof elevation. The mine adit outline was eventually observed to be easily distinguished from the mountainside and was encountered within a few horizontal feet of the slope surface (Photo 30). The adit entrance was discovered to be contained within a resistant ferricrete formation of undetermined thickness and lateral extent. Apparently, because of the steep 44 percent slope, loose talus material was able to slide down-slope over an unknown number of years to collapse and fill the mine portal area.

Excavated approximately 3 feet of collapsed talus material from portal area. Note yellow boy-coated talus material and small piece of horizontal lagging at yellow boy horizon.

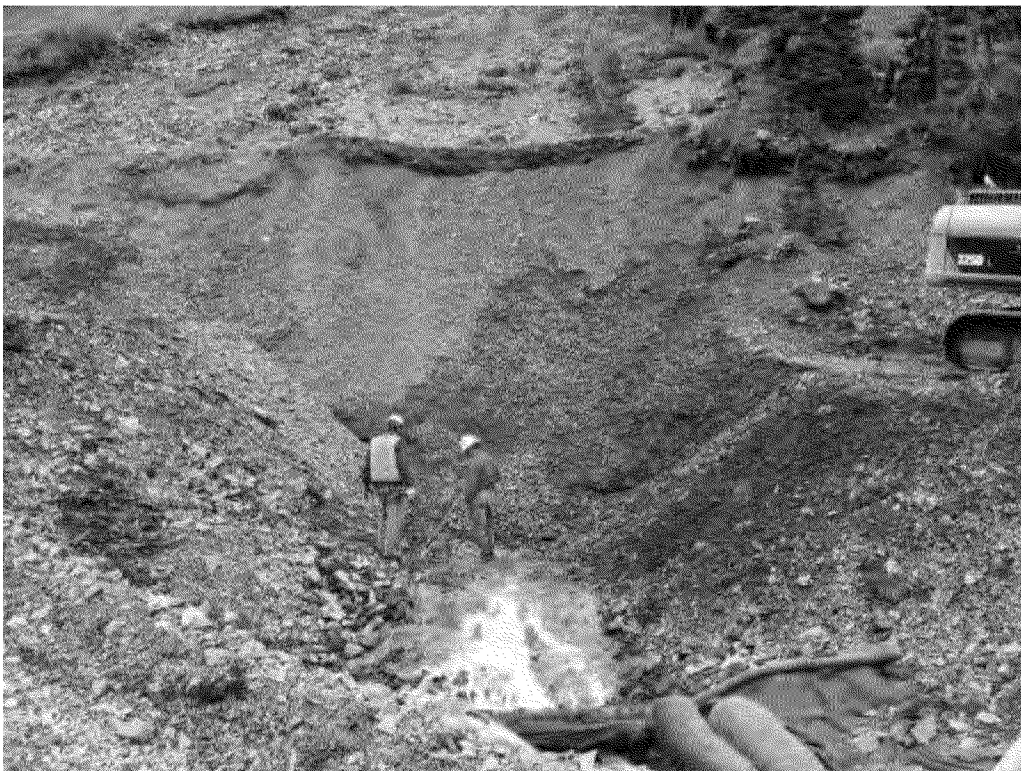
PHOTO 28 9-13-2011

Collapsed portal work area. Removed approximately 6 feet of talus material from in front of adit to level where workman is standing. Top of red staining at dig face indicates upper AMD flow level. Note talus sloughing due to steep slope.

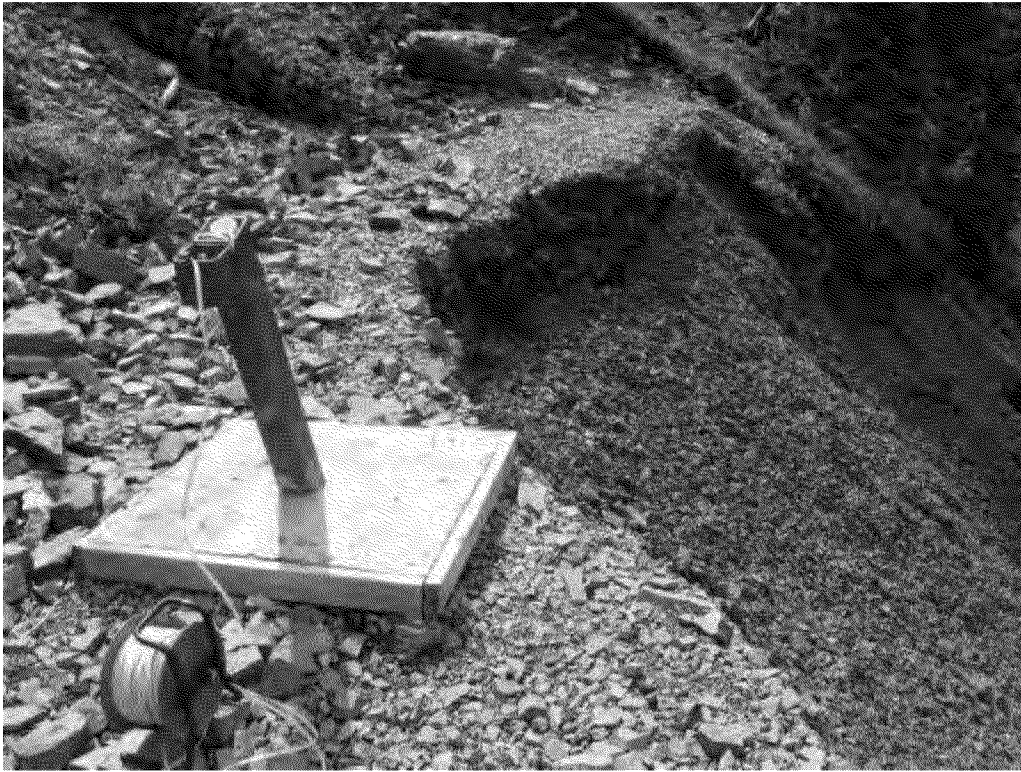
PHOTO 29 9-13-2011

Slope failure at bench above excavation area at collapsed portal. Note water level indicator tool in well.

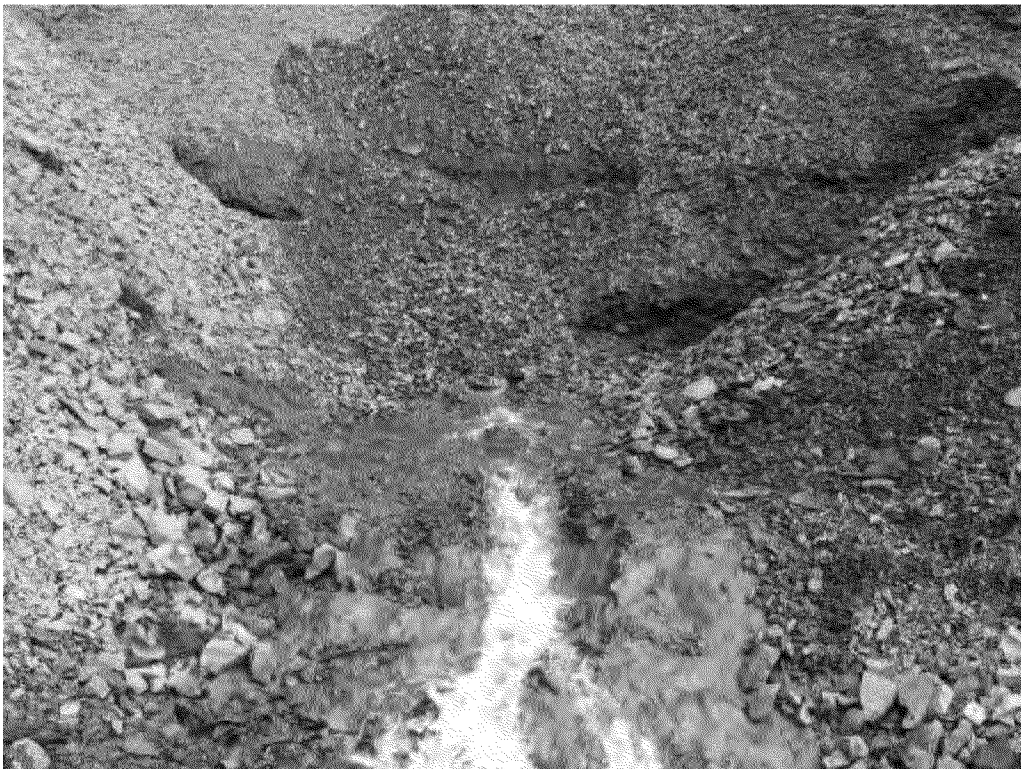
PHOTO 30 9-13-2011

Collapsed portal work area. Dark red ferricrete formation becoming apparent at dig face, visible above right of AMD outflow. Line of red staining in photo top indicates AMD flow level and deposition of yellow boy.

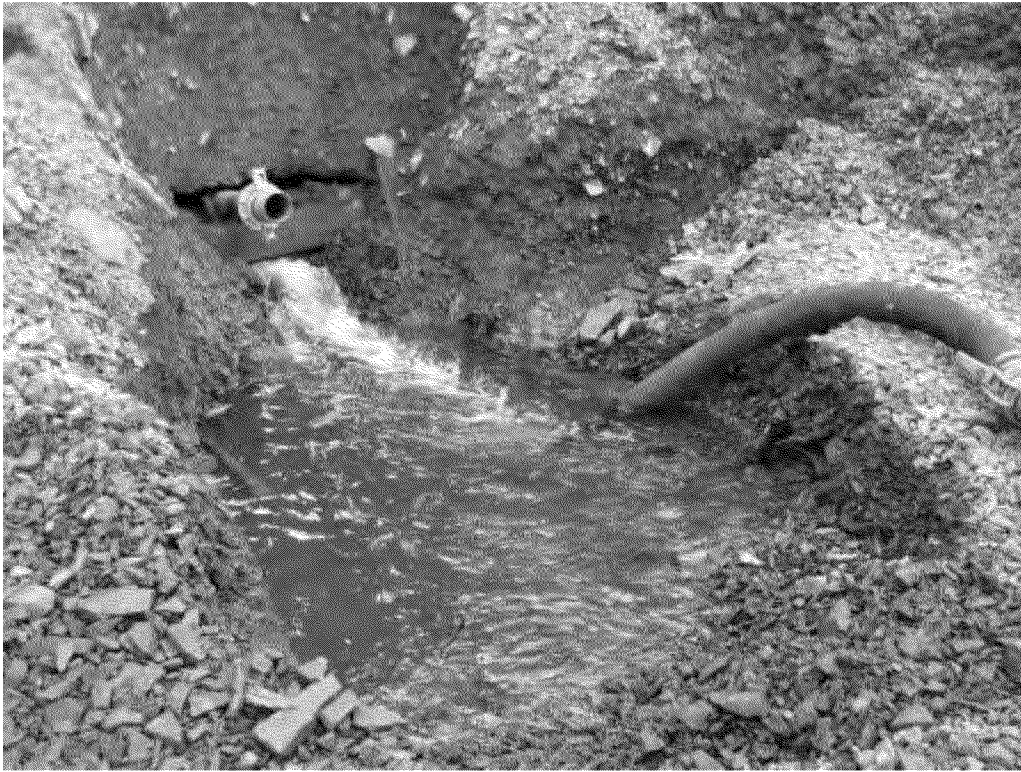
PHOTO 35 9-27-2011

Pumping water through hose from sump at excavated portal. Steel pipe placed in adit is visible resting on header above current collapse blockage.

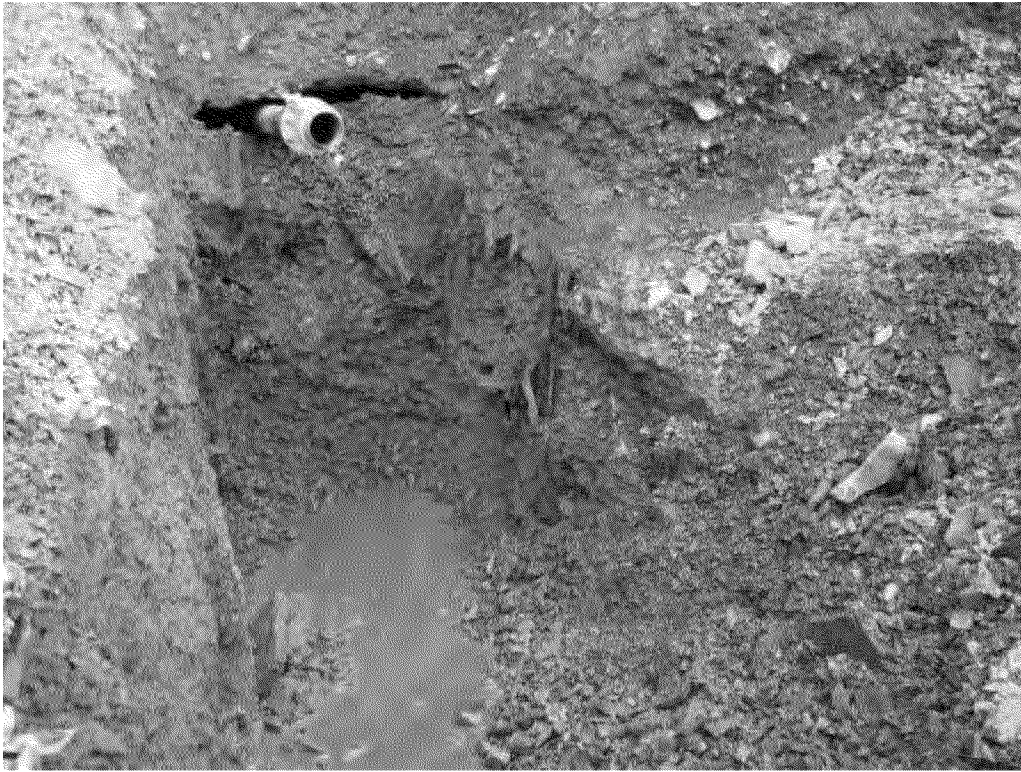
PHOTO 38 9-29-2011

Removing upper portion of remaining collapse material to allow AMD water to flow out of adit.

Invert of adit on solid ferricrete formation under standing water in photo. Note wood debris. Portion of red ferricrete wall visible on right of excavation.

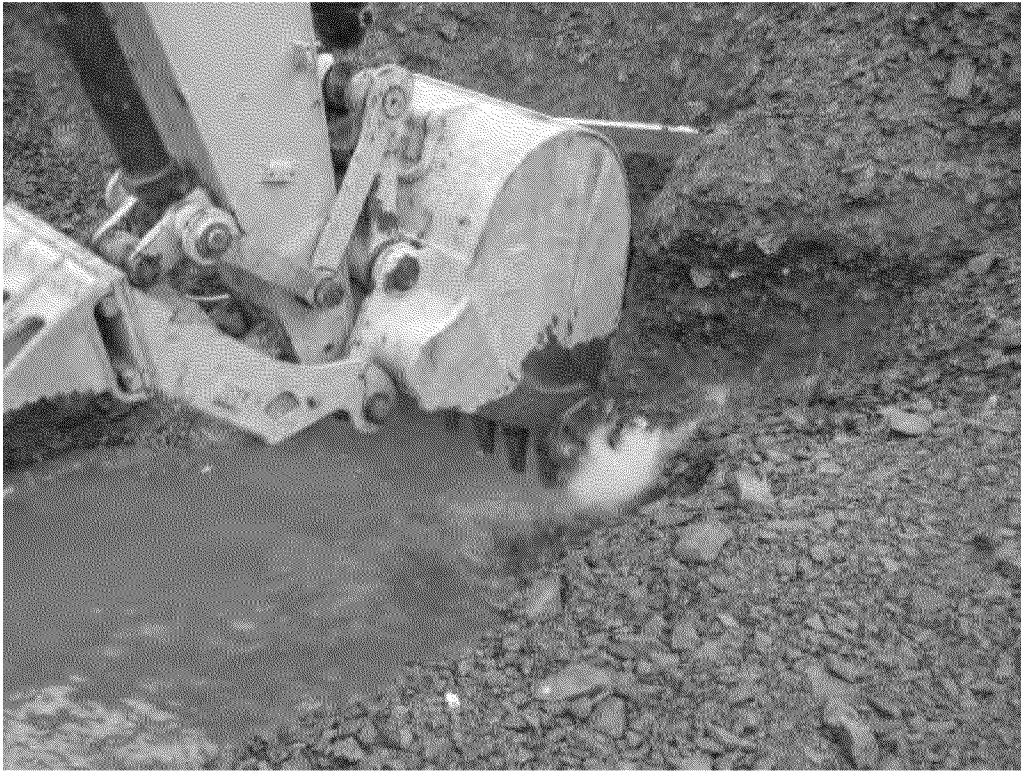
PHOTO 41 9-30-2011

In order to install the new corrugated galvanized metal culvert portal structure as closely to the adit opening as possible, a minor amount of ferricrete had to be broken from the outwardly sloping side walls using the excavator. The ferricrete was very hard and difficult to break from the mountainside (Photo 41). A 10- foot horizontal section of 10-foot diameter culvert pipe was placed to within approximately 3 feet of the top of the sloping ferricrete adit entrance, although the lower half of the culvert pipe fit snugly against the ferricrete rock face where it had been broken out (Photo 42). Douglas fir timber roof supports were bridged from the top of the metal culvert to the ferricrete rock face and covered with loose talus material. A wood timber set was also placed under the roof support at the ferricrete rock face for added support (Photo 43). An additional 5-foot section of galvanized metal culvert pipe was also spliced to the original 10-foot section for a final portal length of 15 feet, leaving sufficient area to access the remaining dump pad. The portal structure rests on a ferricrete floor and, therefore, could not be lowered.

Excavator having difficulty breaking well-cemented ferricrete rock from portal face to accommodate new portal structure.

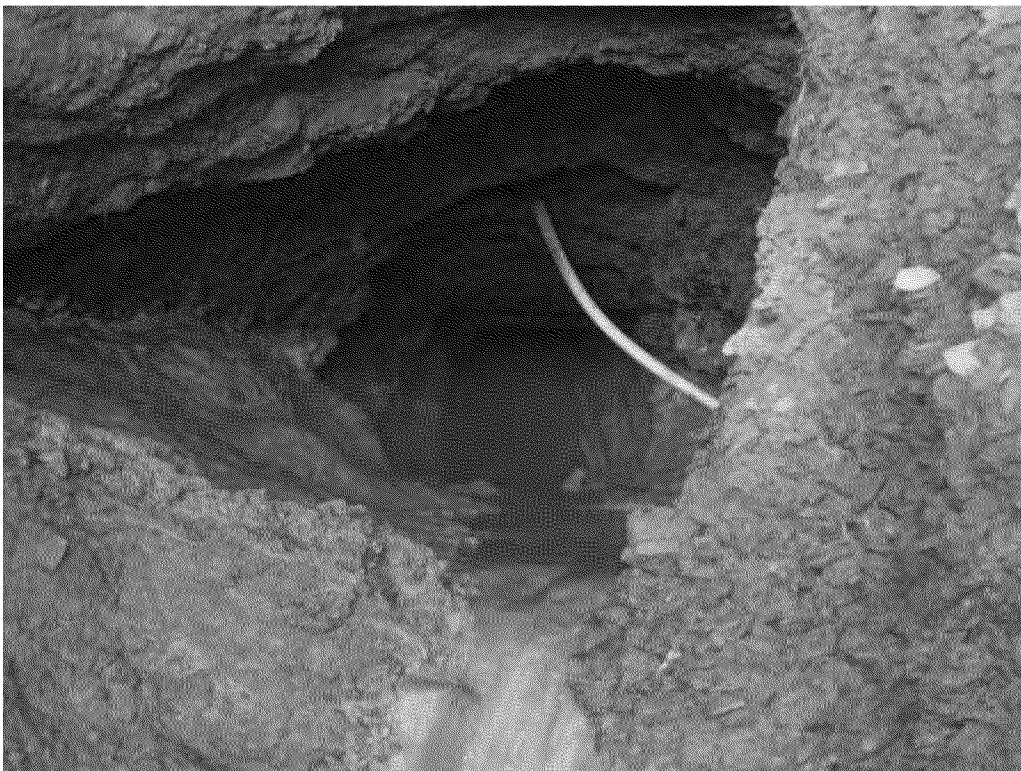
the adit floor at the entrance, and the fines are suspected to become thinner with further entry into the adit, as the adit floor is declined to promote outward water flow. Approximately 4 feet of void space was measured from the fines on the floor to the adit roof. A timber set is observed an estimated 80 feet inby, as well as remnant material including a wood wedge still intact on the right rib near the entrance (Photo 44).

PHOTO 44 10-11-2011
View into adit from portal. Sediment material on floor in photo foreground is 2 feet thick, approximately 4 feet of open space to adit back. AMD water draining down center. PVC monitoring well pipe is visible in adit. Note timber set visible behind PVC well.

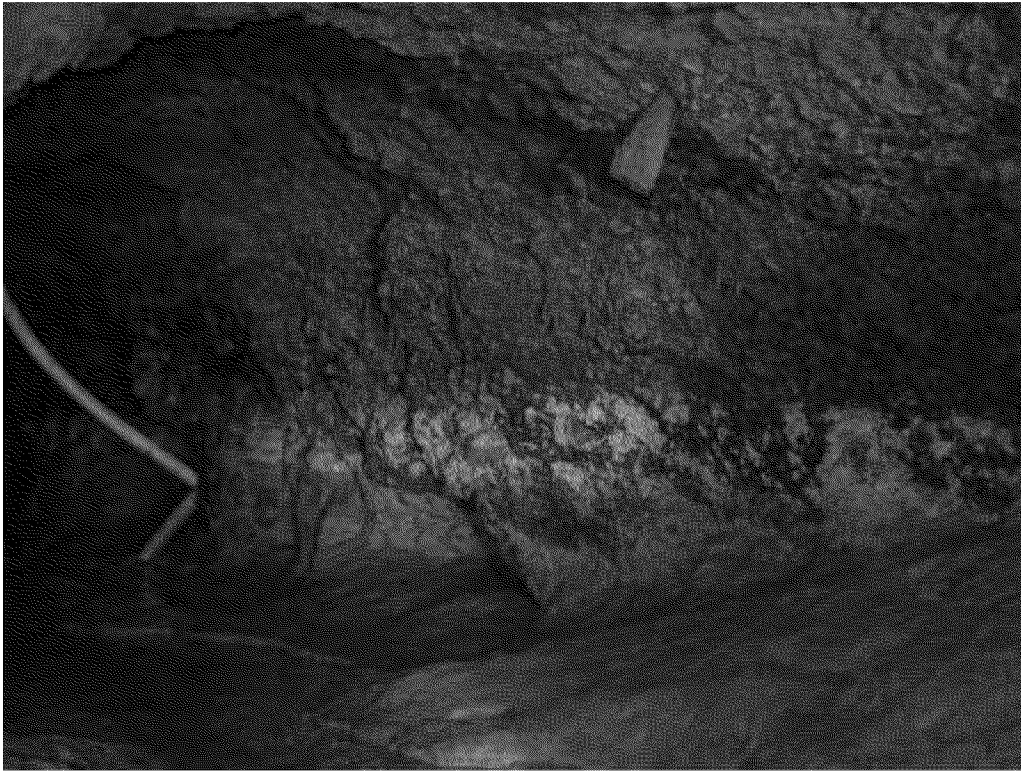
PHOTO 45 10-12-2011

Ferricrete walls inside the adit are stained red, orange, and white (Photo 45). The various colors are likely due to differing metals (likely predominantly iron and aluminum) dropping out of solution onto the rock walls. Apparent integrity of the adit seems to be very good as little collapse material could be discerned on the adit floor, and the adit walls and roof do not seem to be malformed from excessive caving.

Right rib of adit near portal showing various stained horizons on ferricrete formation. Orange-colored yellow boy fines on adit floor, light grey (aluminum hydroxide?) material on wall above yellow boy material, dark red iron oxide staining on back of adit. PVC well pipe in photo left, wood remnant wedge still intact in adit back.

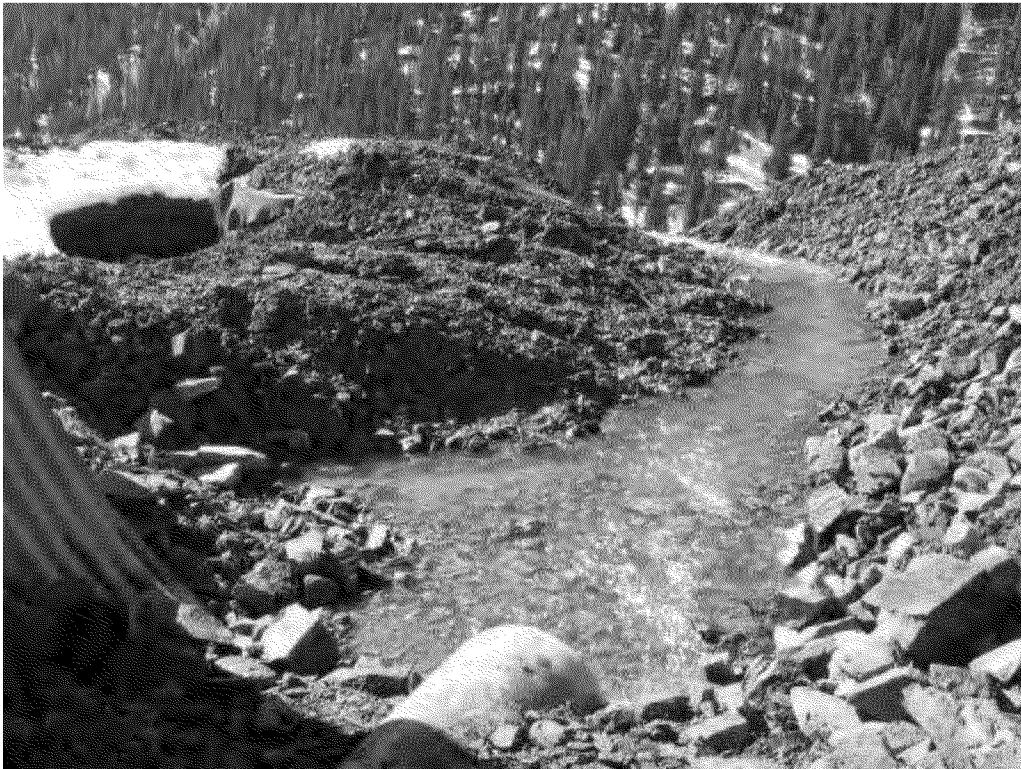
PHOTO 46 10-13-2011

AMD effluent from the adit via PVC pipe at the base of the portal structure. Water is directed to the flow location over the dump face that was in place prior to site activities.

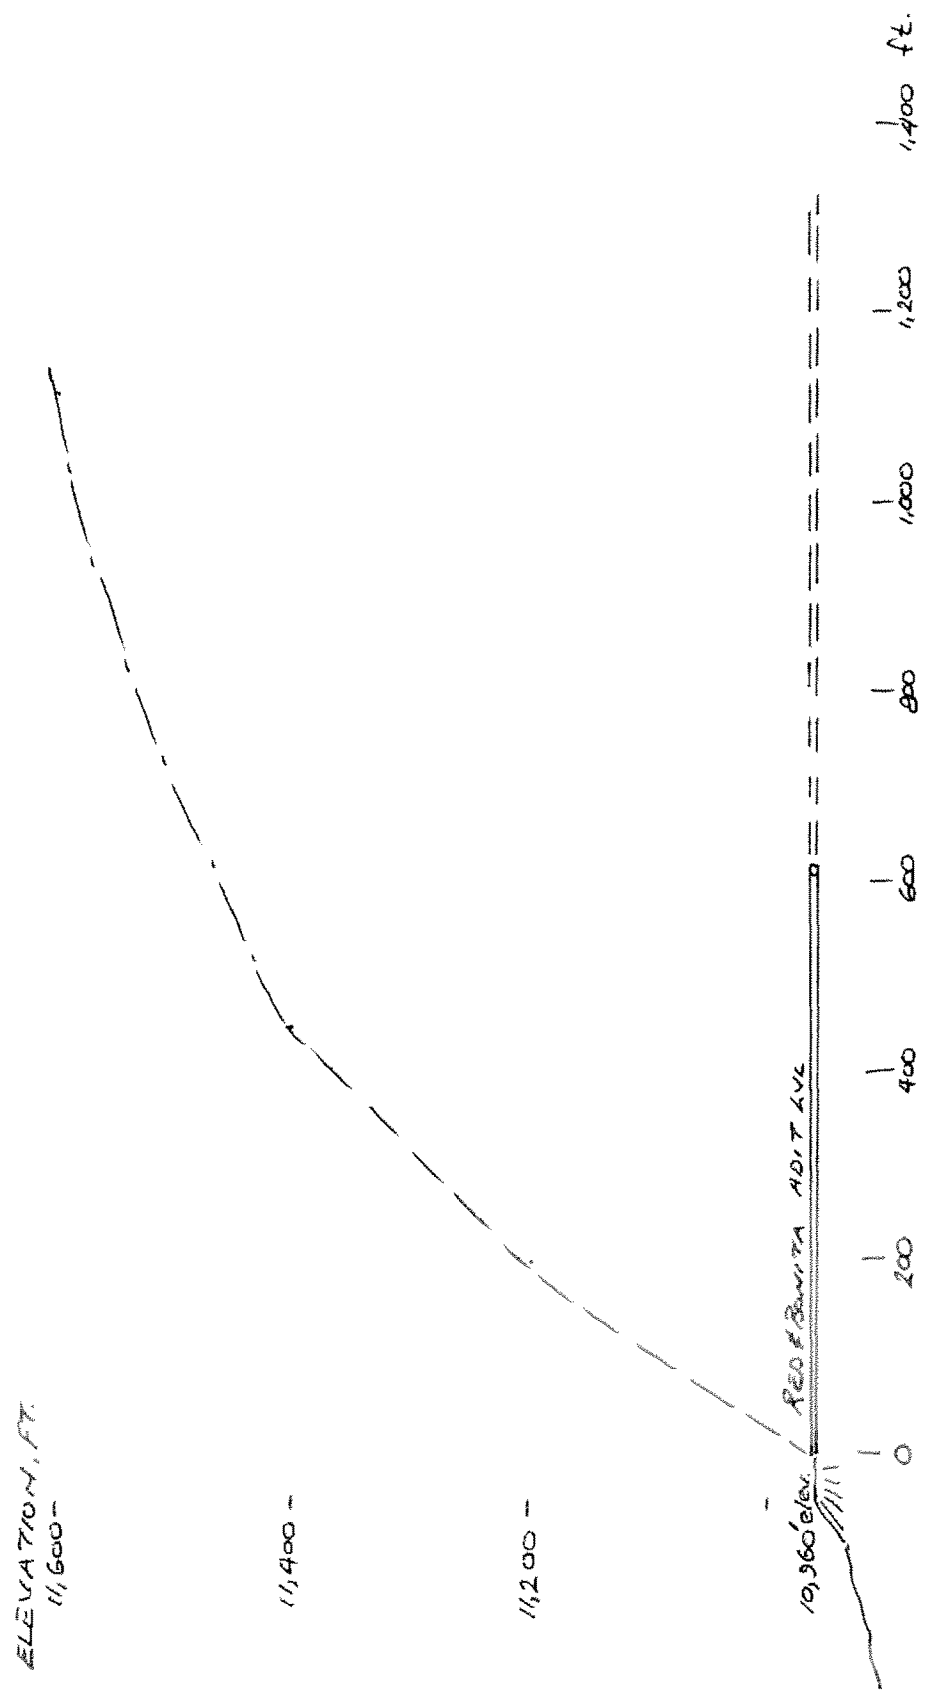
FIGURE 6. DEPTH OF COVER PROFILE ABOVE RED & BONITA ADIT

A preliminary cross section along the R&B workings was constructed as part of the bulkhead feasibility consideration (Figure 6). Due to the extremely steep valley walls along Cement Creek there are 400 feet of overburden at 400 feet in from the portal, and 600 feet of depth at 1,000 feet from the portal. A final bulkhead design must take into account the expected pressure head and depth of overburden available to prevent hydro-fracturing of the rock around the bulkhead. In the case of the R&B workings, it appears that sufficient cover exists to continue consideration of a bulkhead if this approach is chosen.
